Litre 8: The Mark III Rebuild – Updated 23rd June 2022

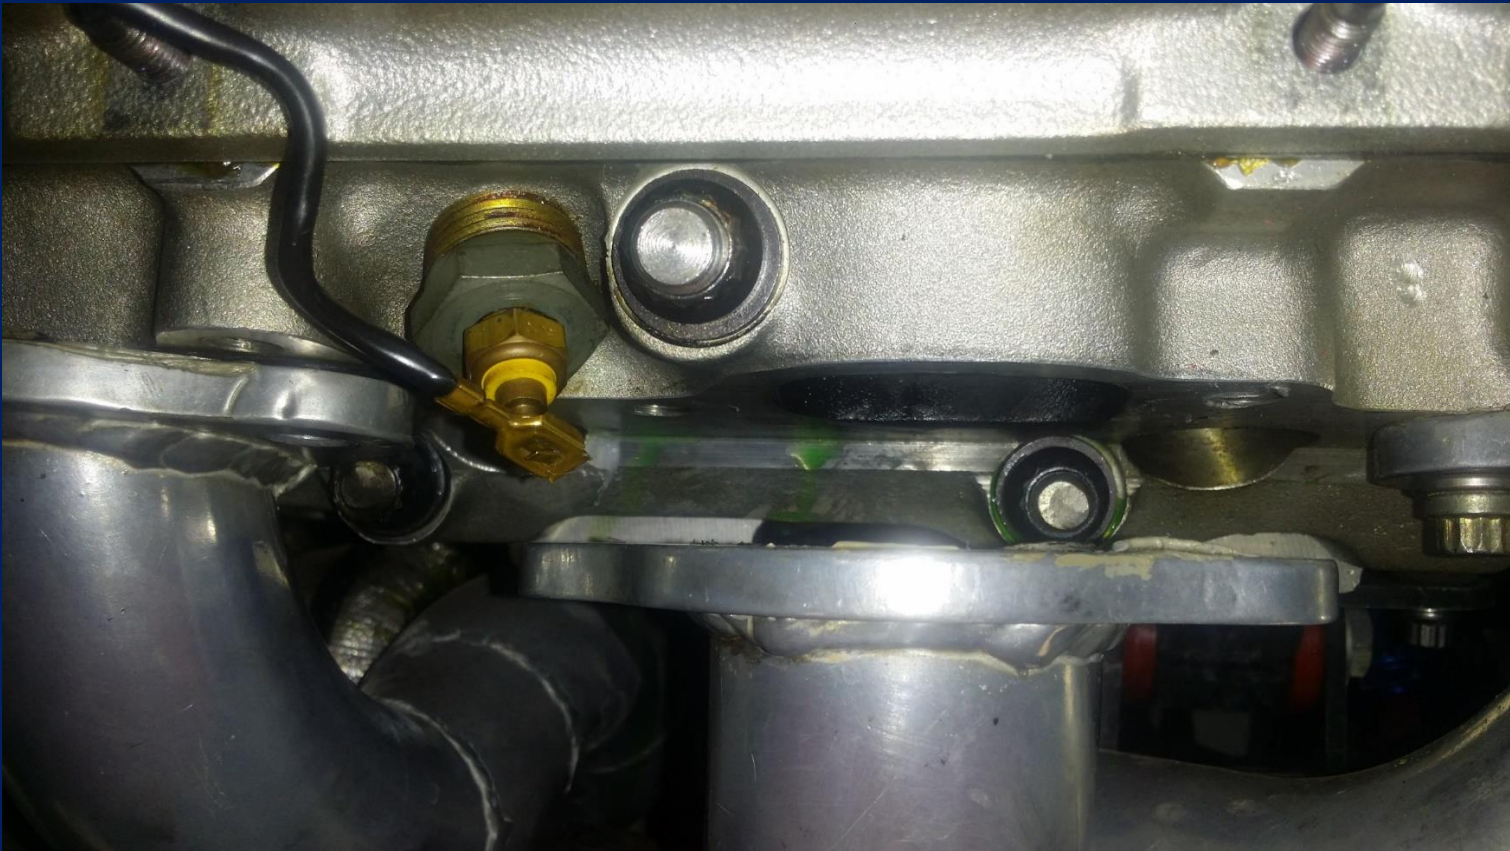
From below it *looked* like the coolant was leaking as the result of a compromised head gasket but no, it was worse than that. Close examination showed that the coolant was leaking from a crack in the Edelbrock Performer RPM cylinder head...

I was (and remain) skeptical of the long term viability of welding this cylinder head. The last thing I needed was for another crack to appear sometime down the track (these particular heads are vintage 1996 and possibly not the greatest casting consistency with respect to internal wall thickness).

So the decision was made to go with some AFR 315 CNC heads along with new pistons and a minimum over bore to ensure good wall integrity while still giving optimum piston ring sealing. The old Edelbrock Performer RPM heads had much work done on them with respect to porting and valves so going back to out-of-box versions of the same cylinder heads would be a big step backwards.

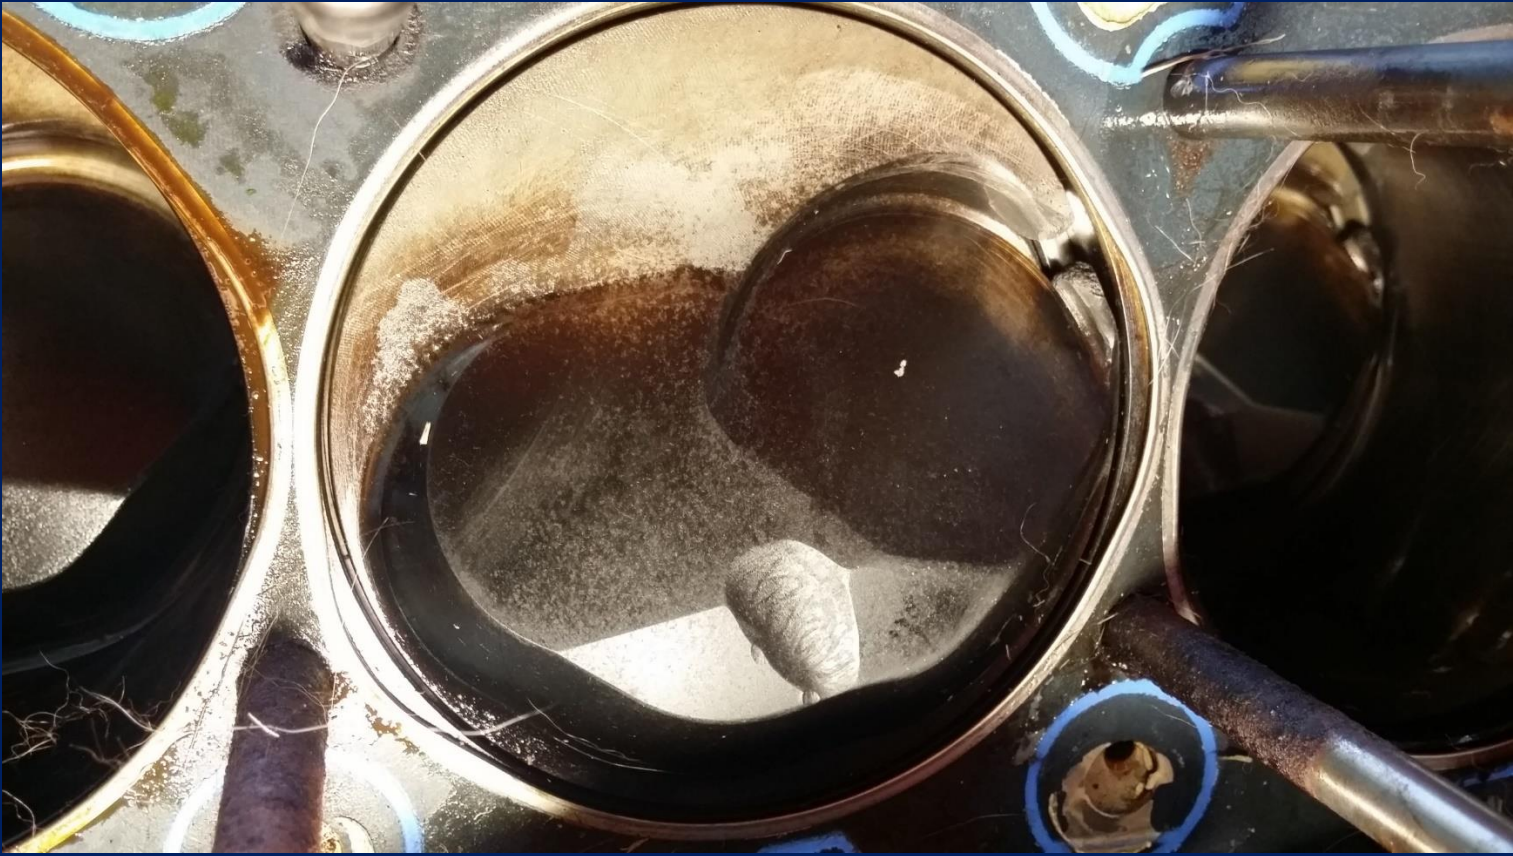
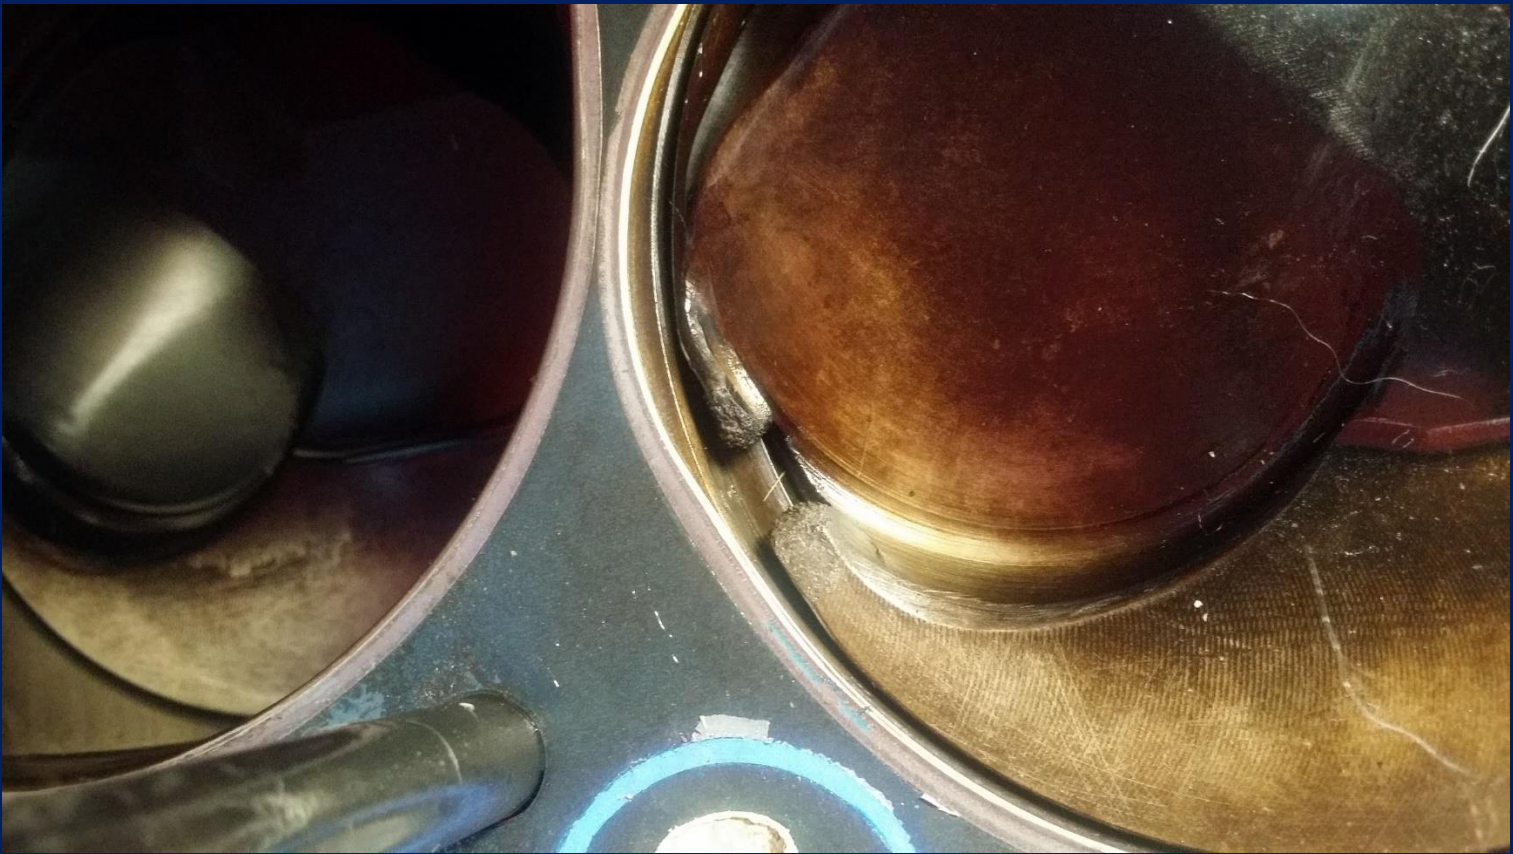
With the heads off other issues became apparent...

The pistons in the 4 centre cylinders (3,5 & 4,6) all show damage on the top ring land and the culprit was deduced to be pre-ignition.

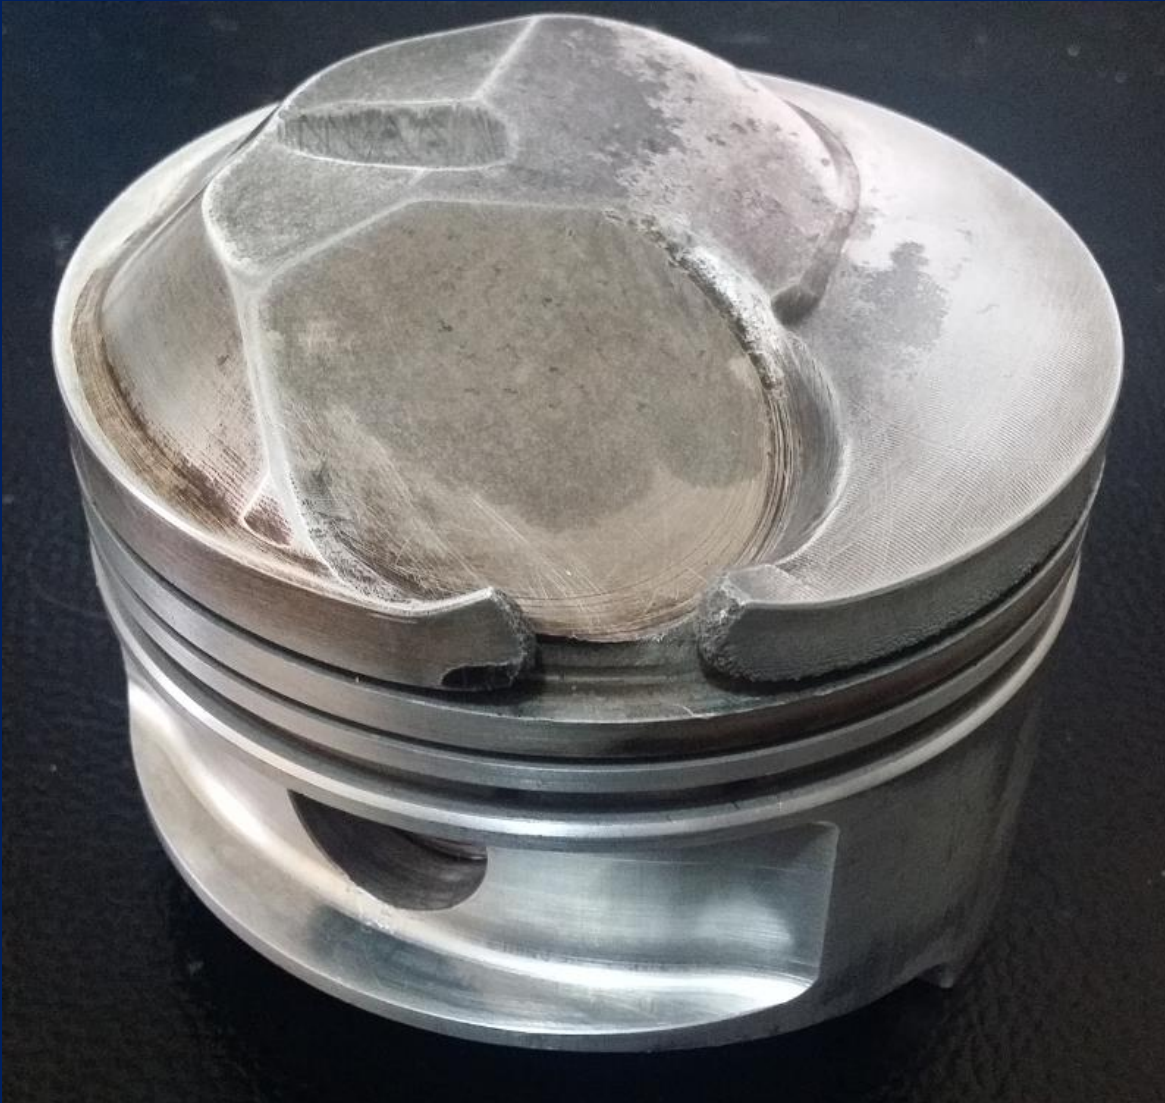
The damage is more apparent in the image below:

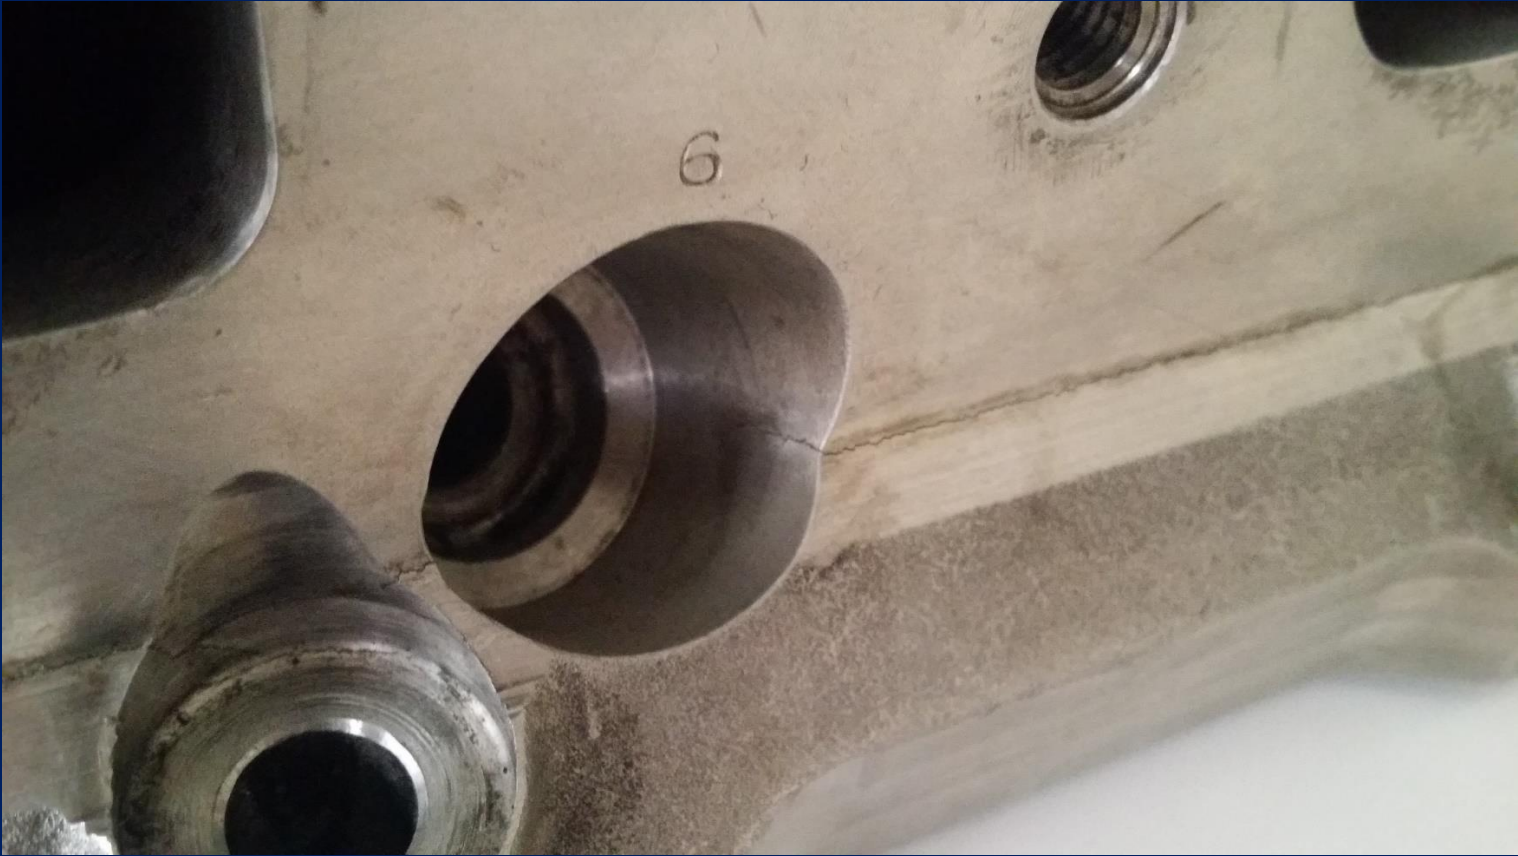
Regarding the cracked cylinder head, the crack is clearly visible below and it extends between cylinders 4 and 6,

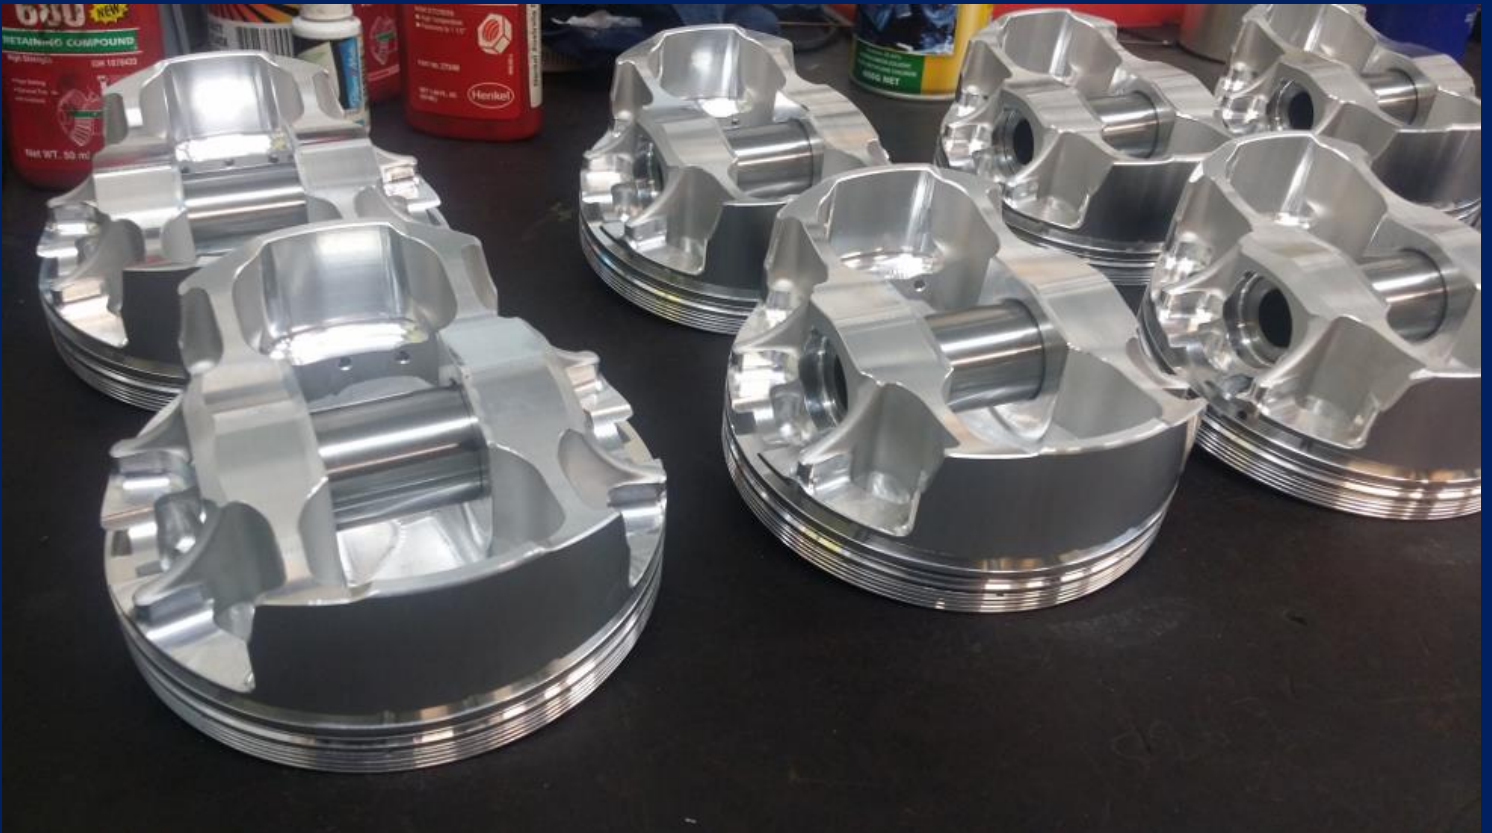
The JE Forged Lightweight FSR Pistons have a very short skirt and a 1.120" Compression Height.

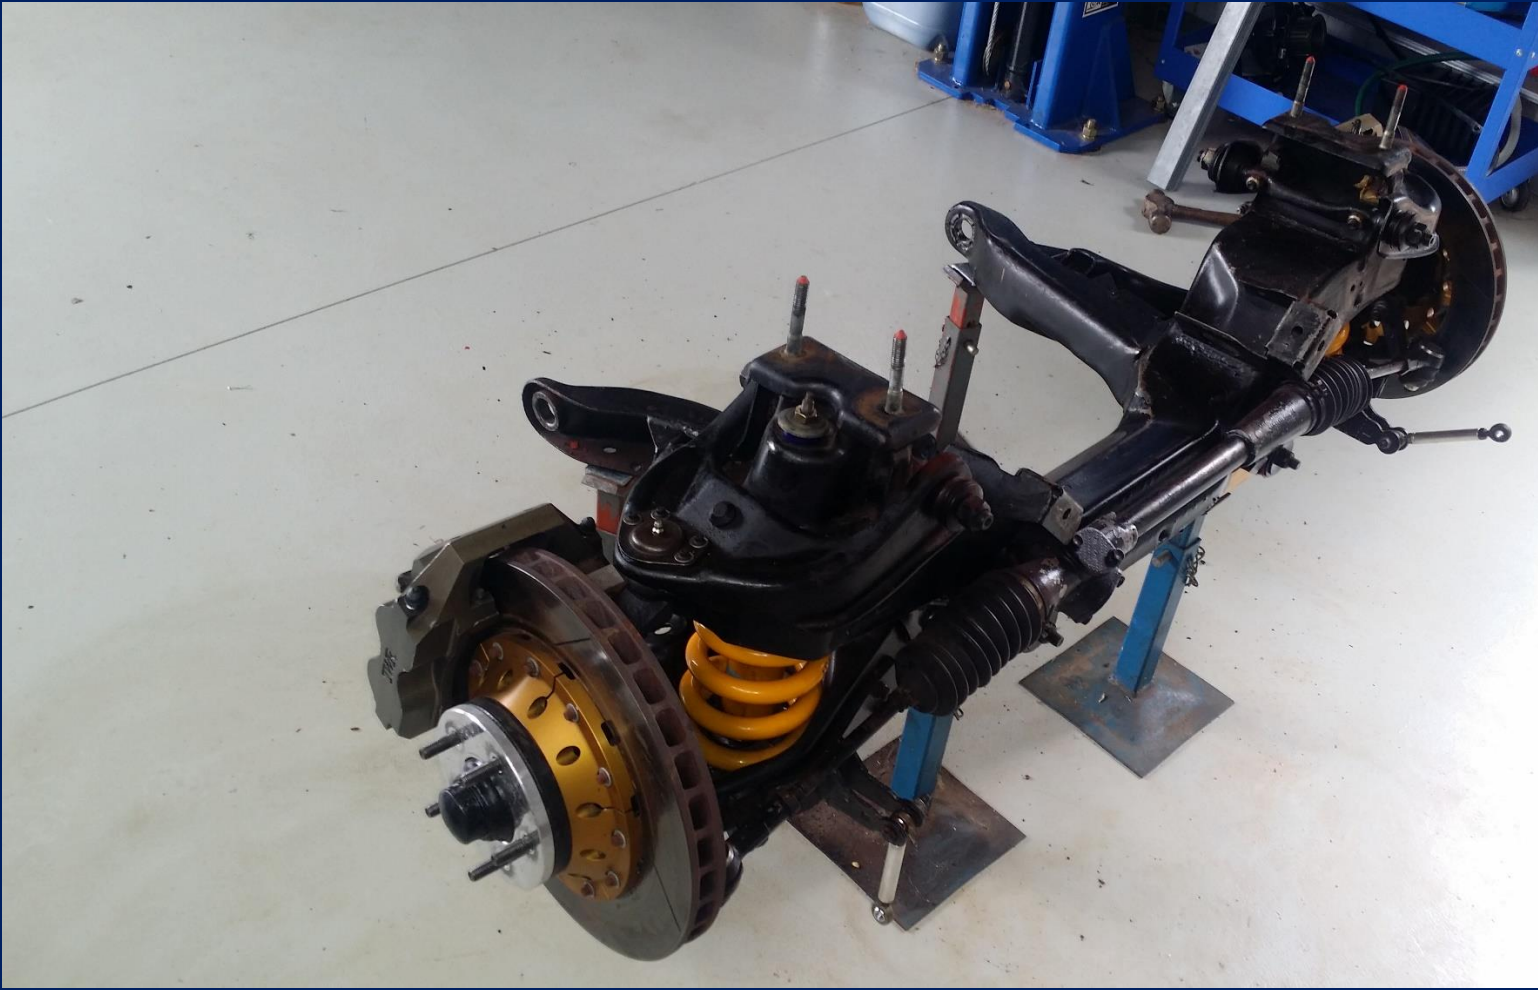
A major surprise was the condition of the Nolathane Subframe, Outrigger and Steering Rack bushes. They were like new even though they were installed 28 years ago!!!! I had already purchased Super-Pro replacements and I will install these except I will retain the Nolathane 2 -piece Outrigger bushes, they just look a nicer part than the 1-piece Super-Pro items.

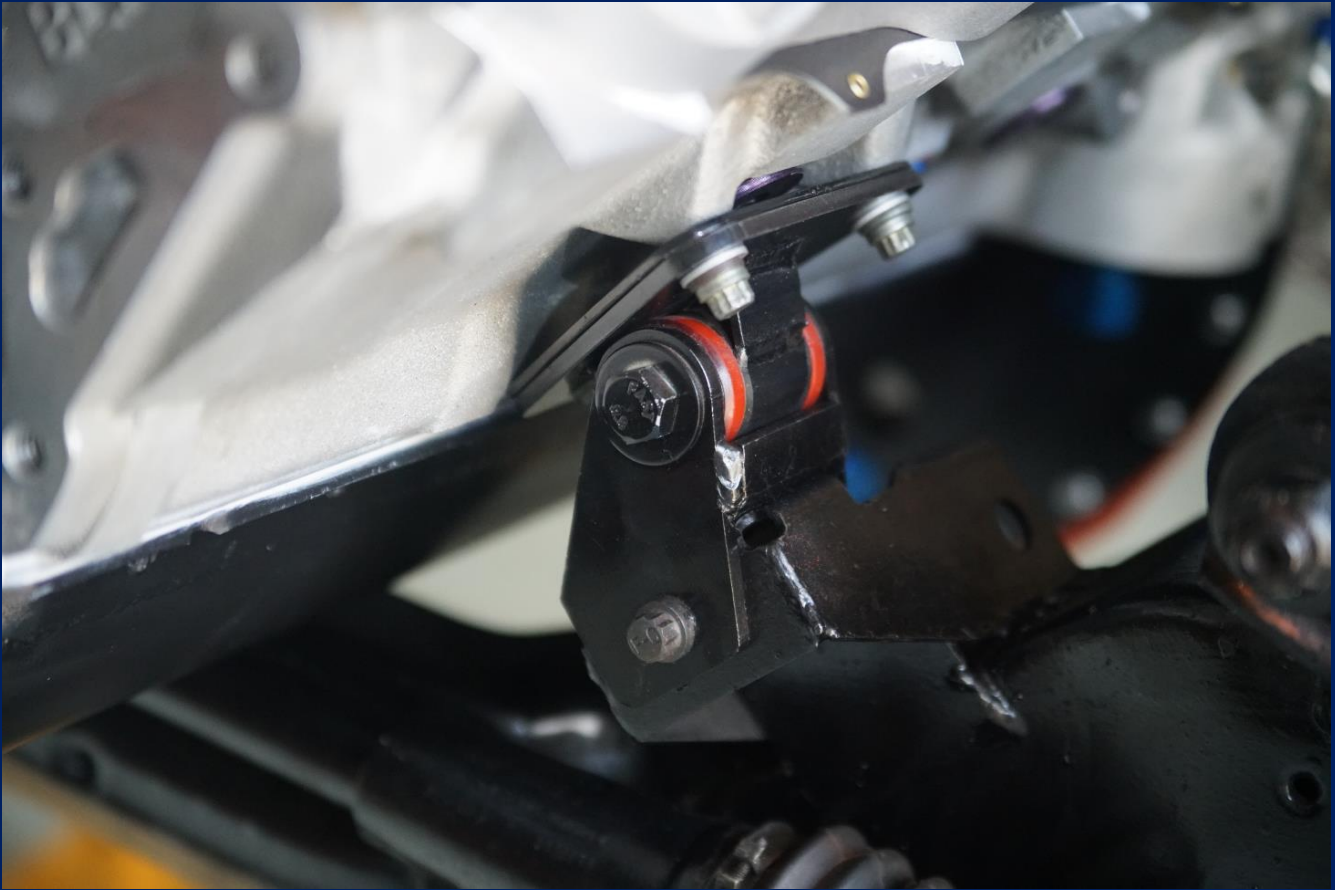
The TuffMounts were reused, still in perfect condition:

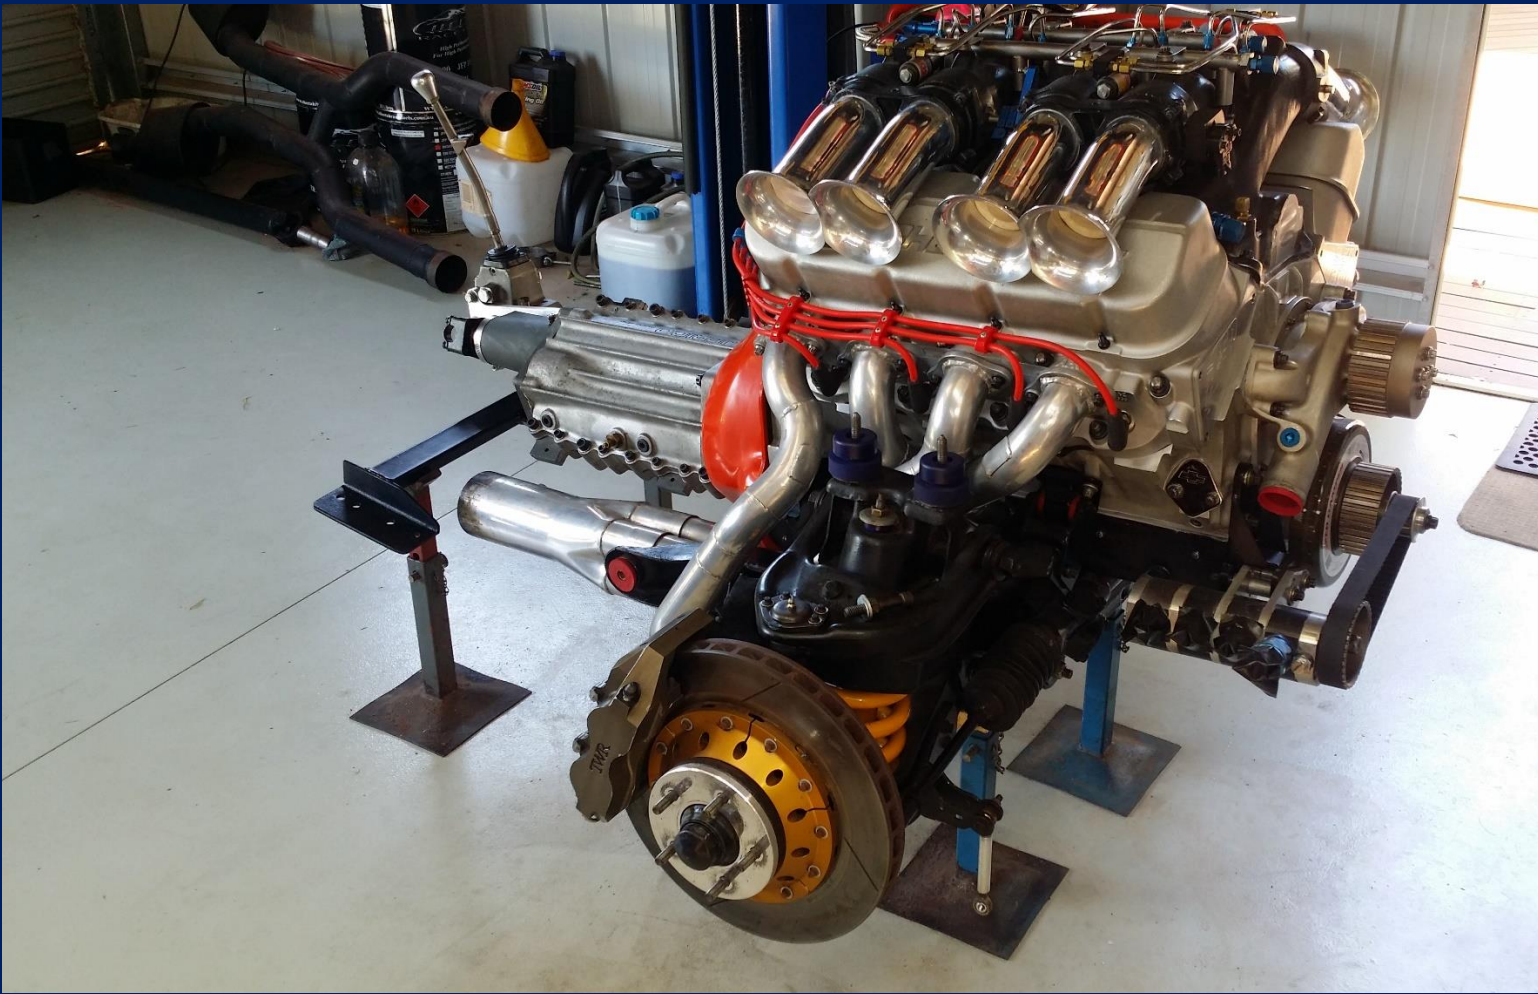
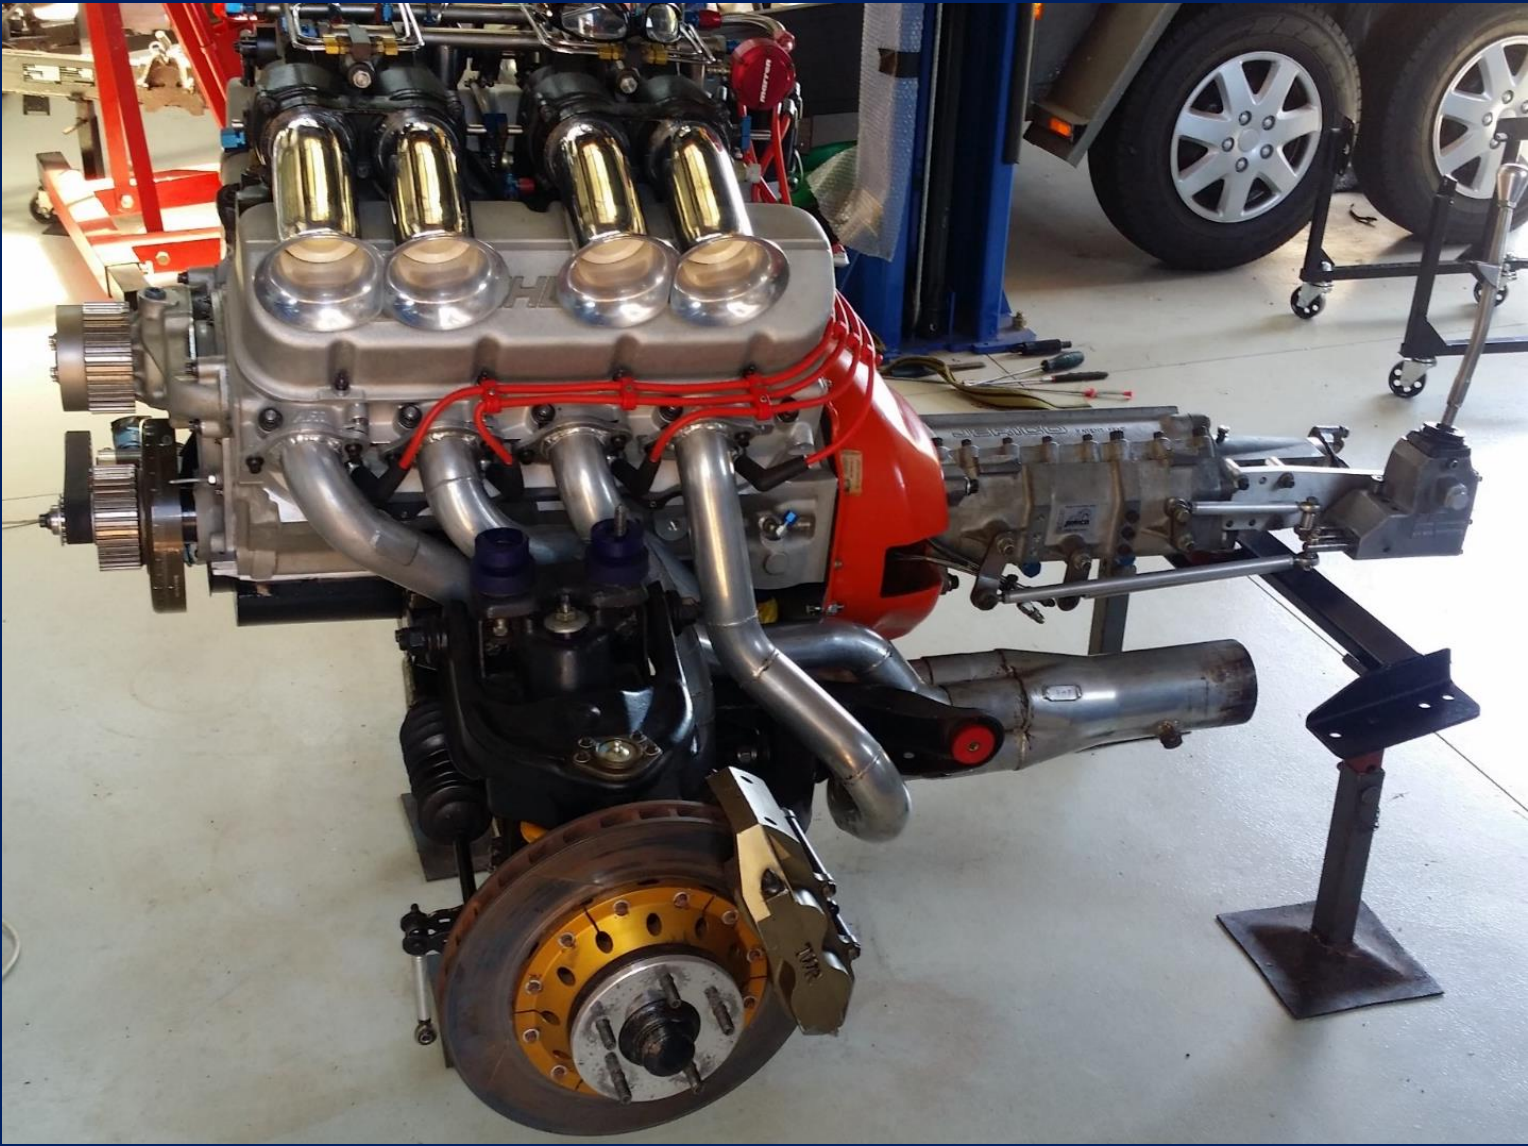
I was very pleasantly surprised that I did not have to do any significant work to the headers (except #8) to get them to fit and clear everything! You have to win some.....

Next is install the starter motor and finalize the header fitment (tidy up a few places on the scatter shield rim lip where I had to grind some header pipe clearance).

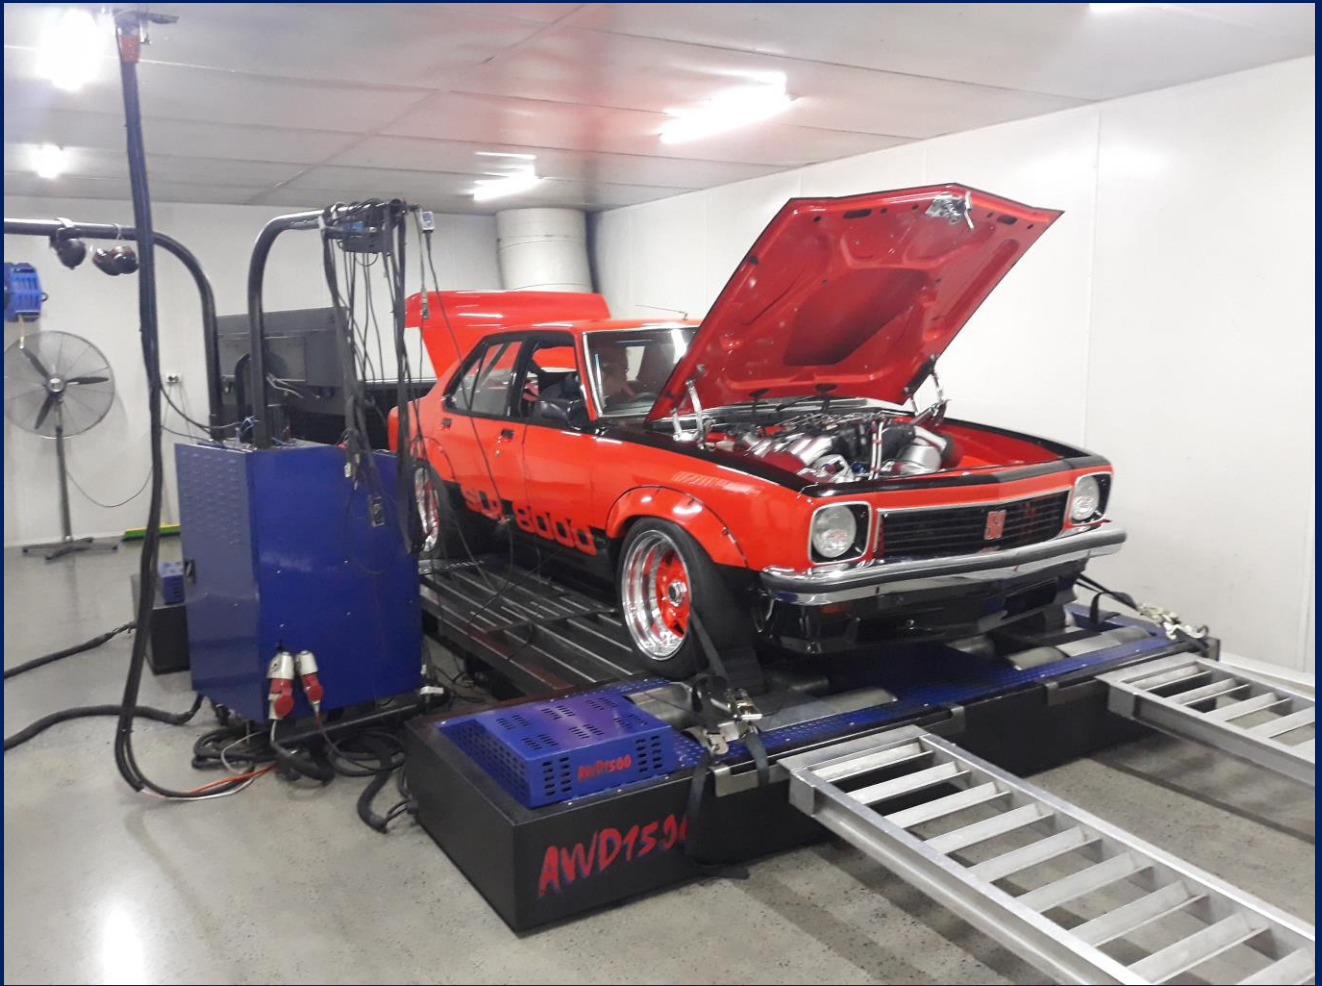
Mainline DynoLog Chassis Dyno Report

Max: ■ dTorque= 927.0NM @ 138KPH • Power= 523.8KW @ 214KPH ▲ Motive Force= 10921N @ 138KPH

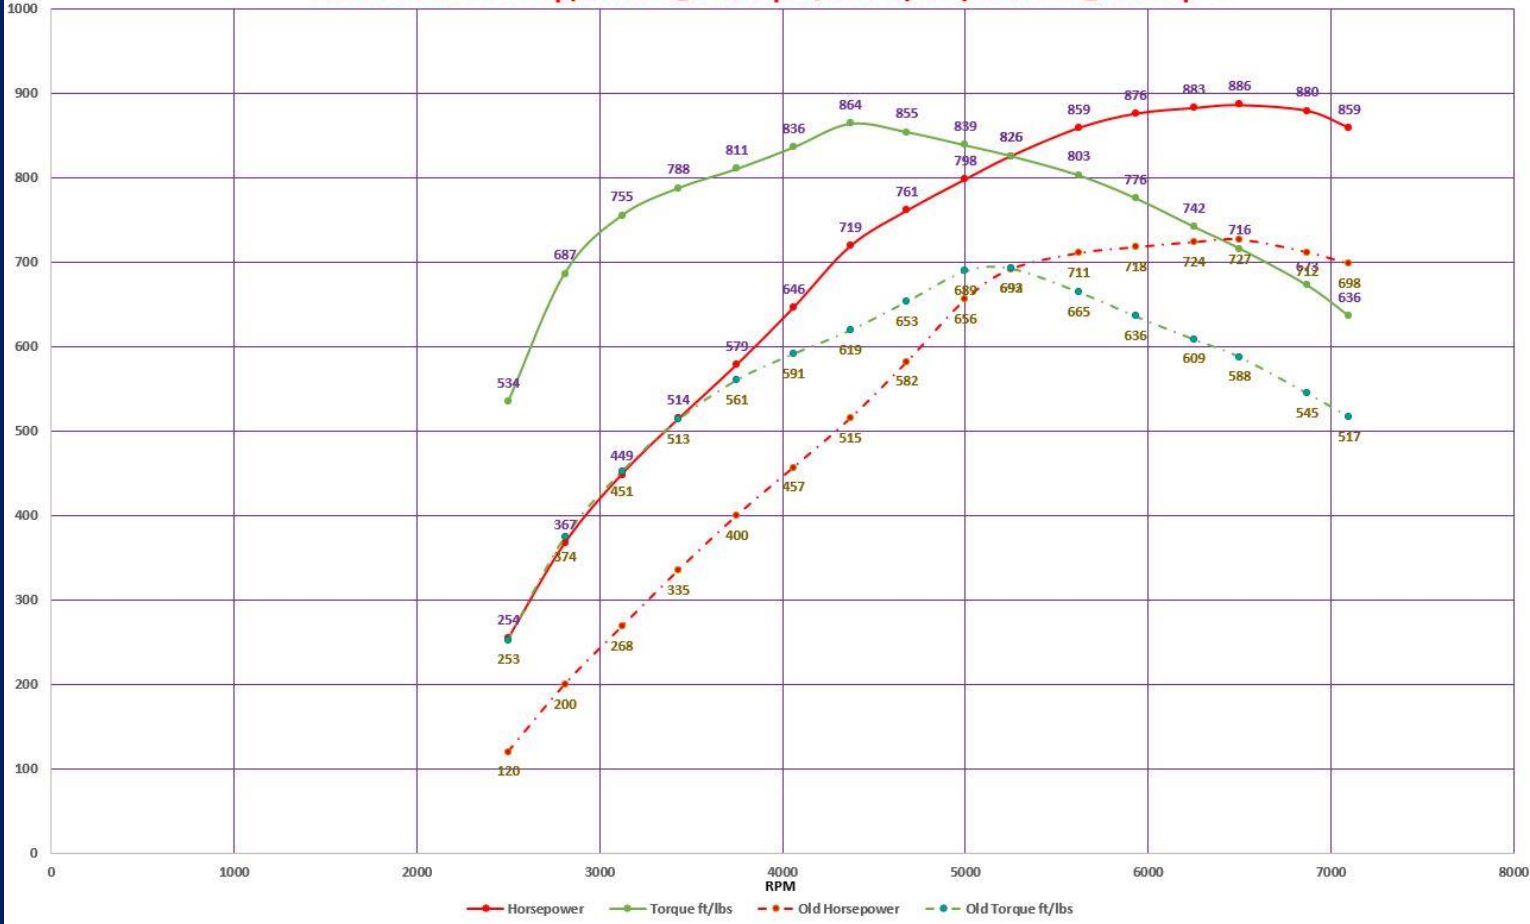
Dyno Chart Comparison (Flywheel)

Litre8 564ci - 886 hp/664kw@6560rpm, 864 ft/lbs /1172nm@4370rpm

Litre8 478ci - 727 hp/542kw@6500rpm, 695 ft/lbs /940nm @5150rpm

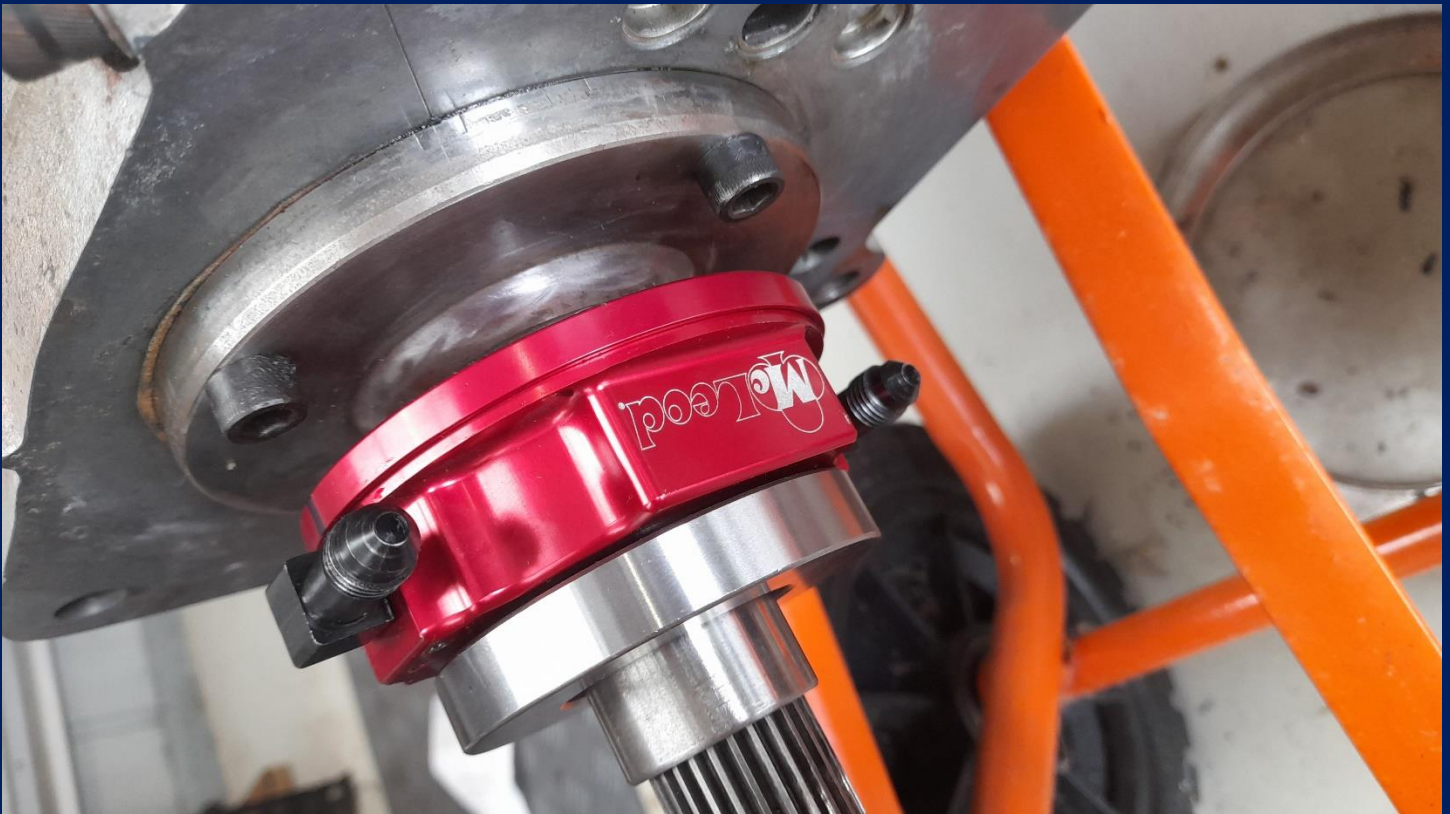
Clutch assembly and flywheel ready for some expert inspection. Luckily all was in great shape, another 20+ years left in the clutch plates (based on current wear rate)!

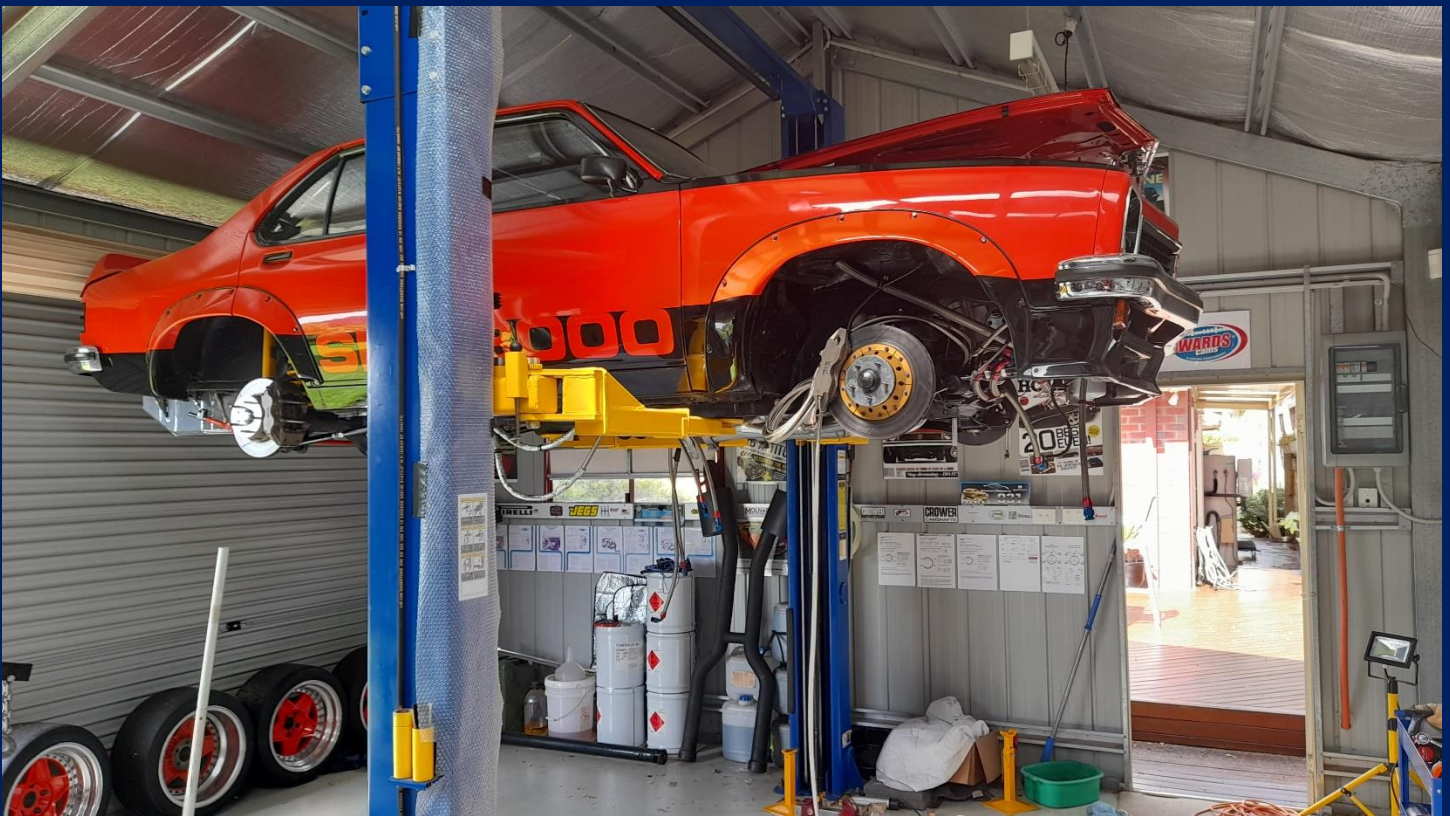
Apart from a new braided pressure line it was apparent that the earlier clutch release bearing was the wrong size for the B&B diaphragm fingers so we replaced it with the correct one.
